XRD-56

AEC RESEARCH AND DEVELOPMENT REPORT

USS BANNER (APA60)

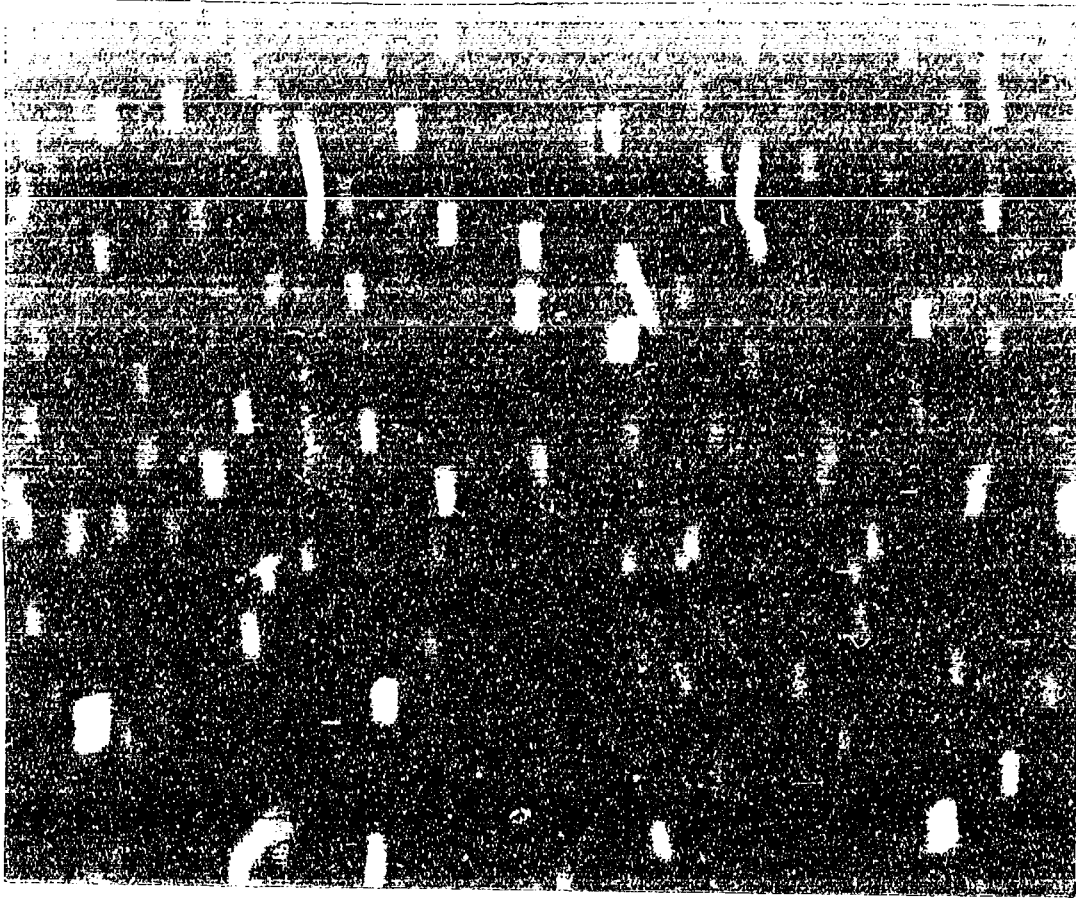
A fire started by heat radiation destroyed the starboard lighting, searchlights, portable announcing equipment, and various electrical cables and junction boxes on the starboard signal bridge. (Photo. 1733-1, page 45). Signal lanterns were burned, exposed electric lines were scorched.

AA-CR-65-1733-1. Damage caused by fire in starboard flag bag.

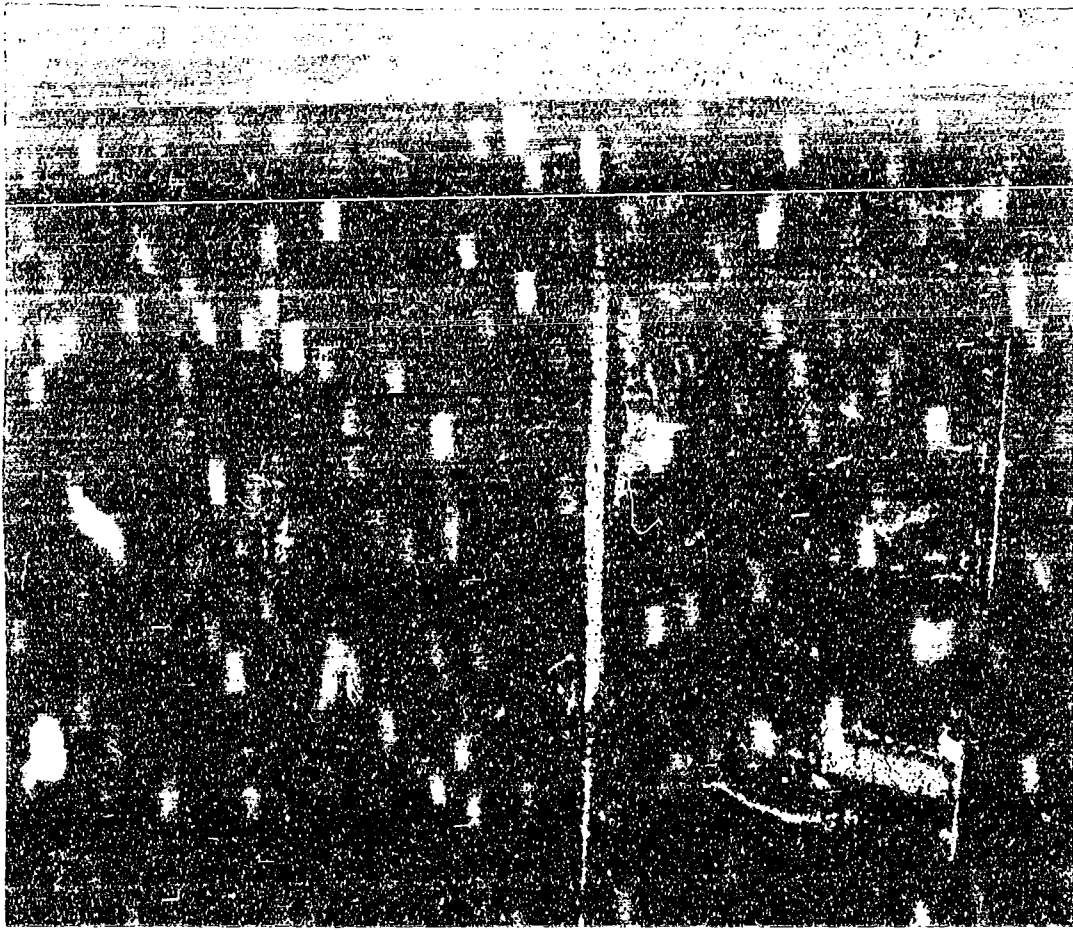
AA-CR-82-1830-1. Holes and dents in pontoons of after cargo hold.

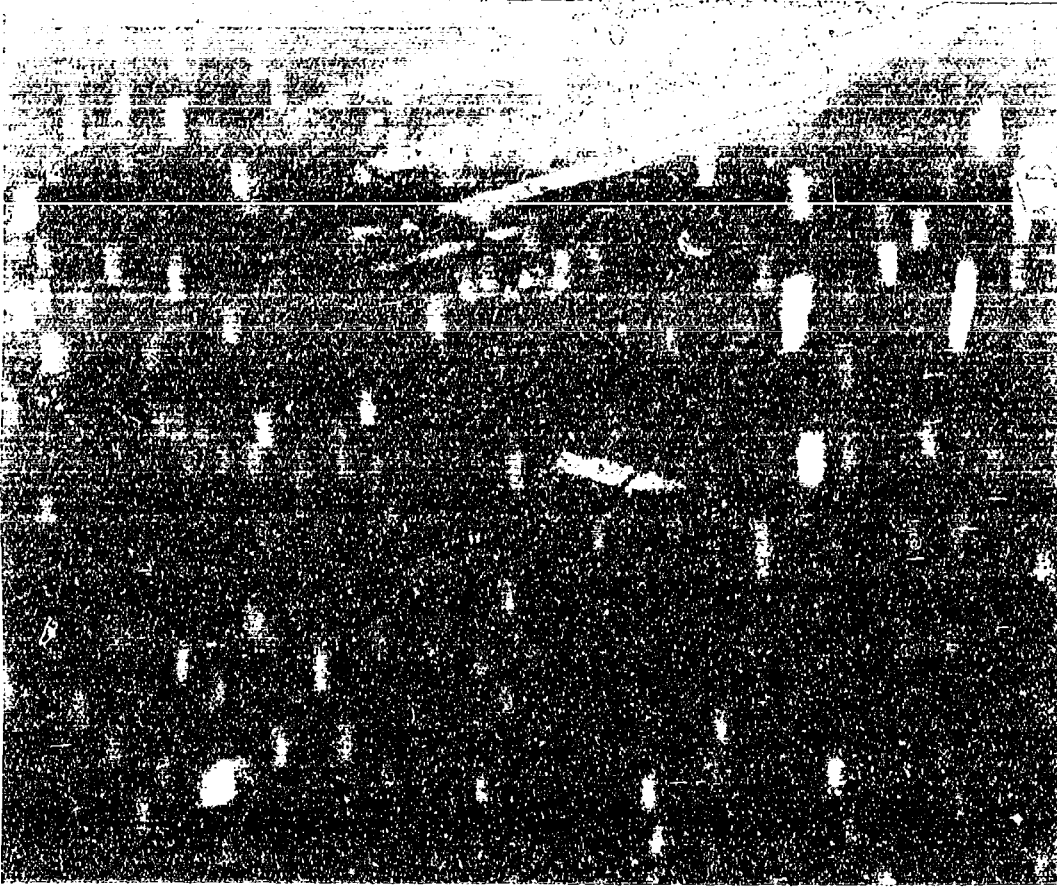
AA-CR-79-1814-11. Wreckage on main deck in forward hold.

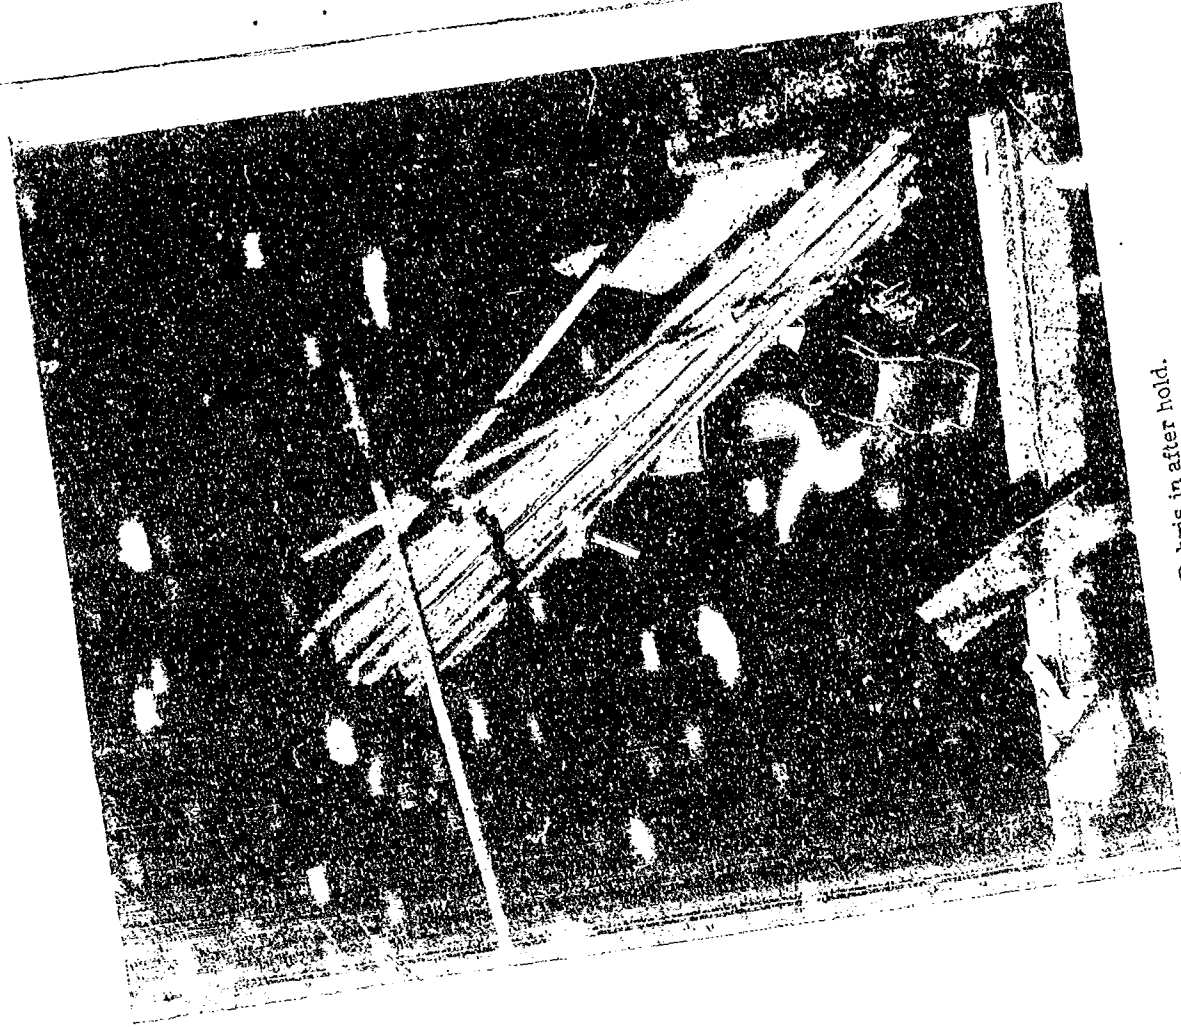
AA-CR-79-1814-8. Debris in after hold.
